SPORTSOUND AMPLIFIER FIELD GUIDE

DD3318172
Rev 05
12 November 2020

DAKTRONICS

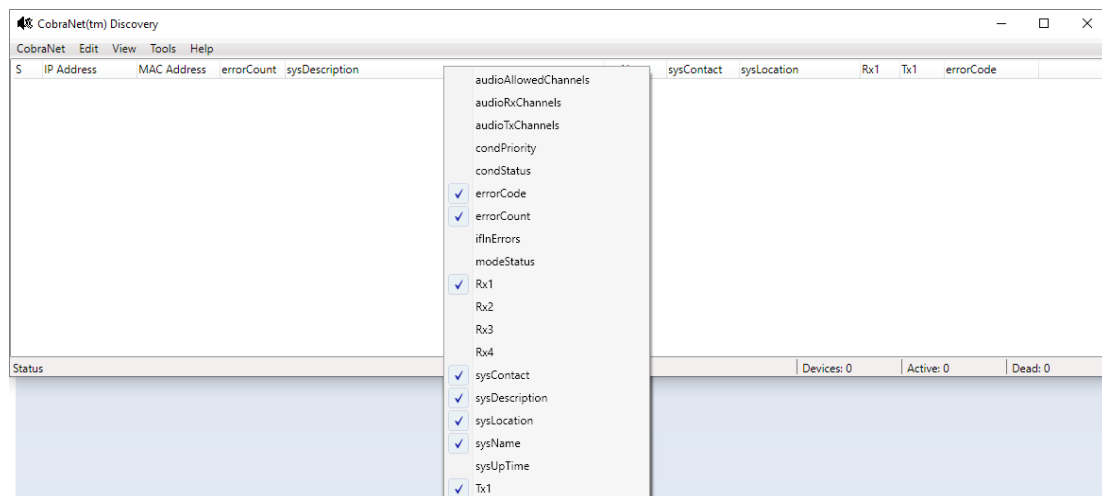
Figure 3: CobraNet Discovery Data Fields

4. Set CobraNet Discovery explorer view to display these data field columns of interest (**Figure 3**): IP Address, MAC Address, errorCode, errorCount, sysDescription, sysName, sysContact, sysLocation, Rx1, Tx1

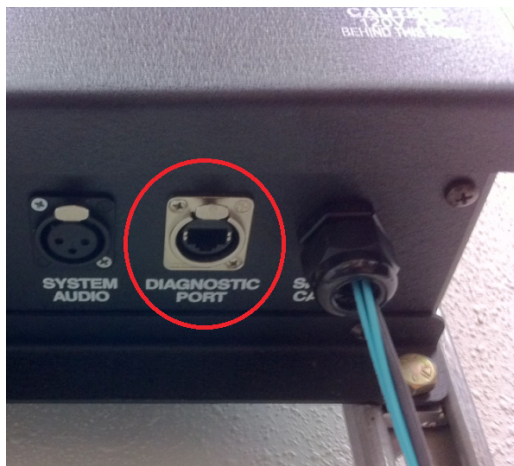
Figure 12: Fiber Box Diagnostic Port

1. Ensure the audio cabinet and fiber conversion box are powered on.
2. Plug your computer into the audio system network using a Cat5 Ethernet cable. Older fiber boxes have an Ethernet jack labeled **DIAGNOSTIC PORT** on the bottom (**Figure 12**); for newer fiber boxes, open the access door and connect to an open jack on the network switch (**Figure 13**).

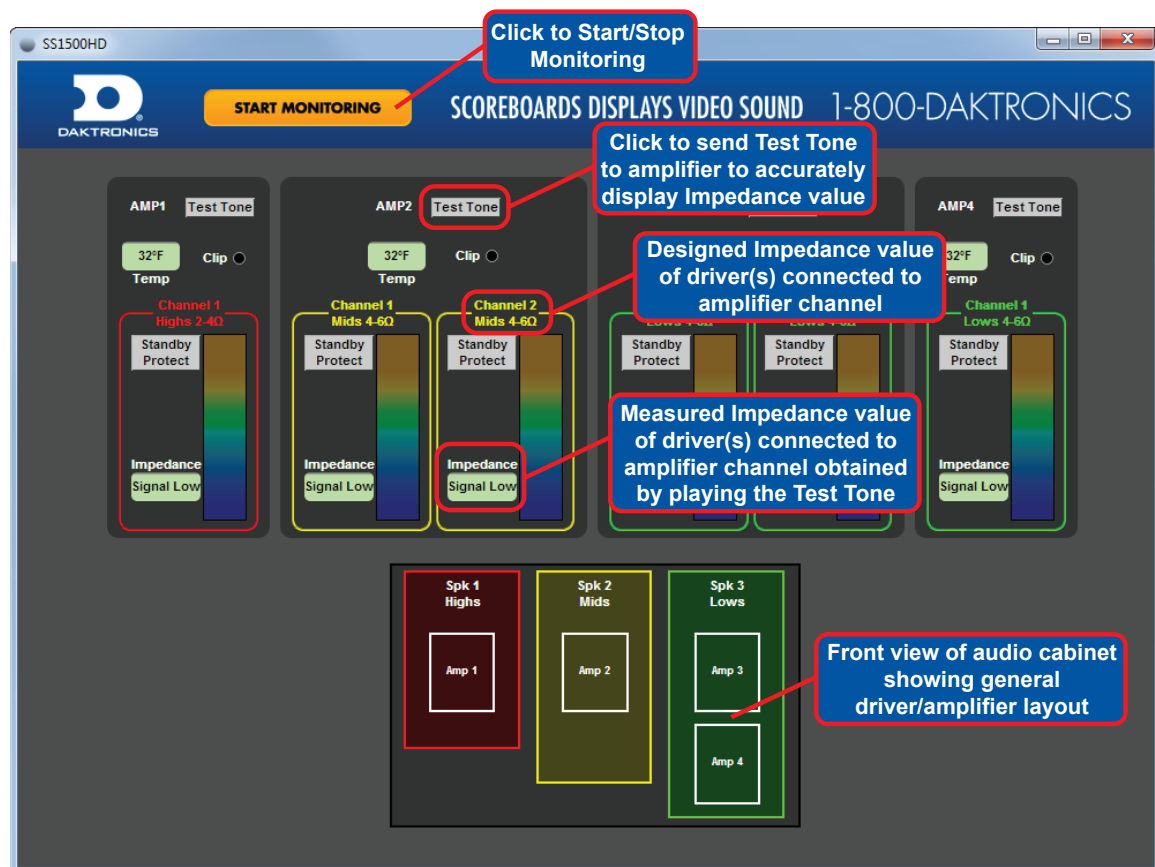
Figure 24: Monitor Application Overview

Refer to **Figure 24** for an overview of the features of the 1500HD monitor application.

Note: If any of the amplifiers do not display the proper IP address or any part of the firmware as outlined in **Updating Firmware (p.8)** and **Setting Static IP Addresses for Speaker Power Amplifiers (p.14)**, the monitor panel application will not correctly function.

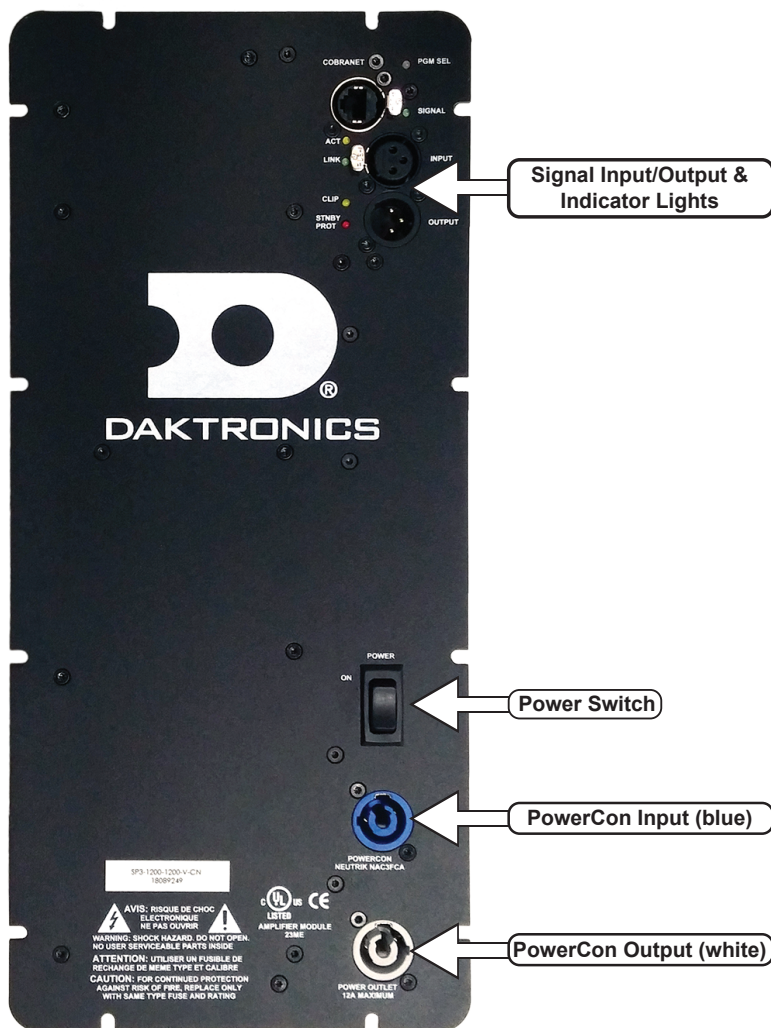
Figure 25: Amplifier Connectors, Indicators, & Switches

If devices are still missing, the amplifiers in the audio cabinet (**Figure 25**) must be accessed to further troubleshoot the problem:

4. Check incoming voltage on blue PowerCon input cable. Refer to the table at right.
5. Check that the amplifier fuse is good.
6. If all checks are correct, but amplifier is not turning on, it must be replaced.

If the amplifier is still not recognized in CobraNet Discovery, or the LINK indicator is not lit, the CobraNet chip cannot connect, and the amplifier must be replaced.

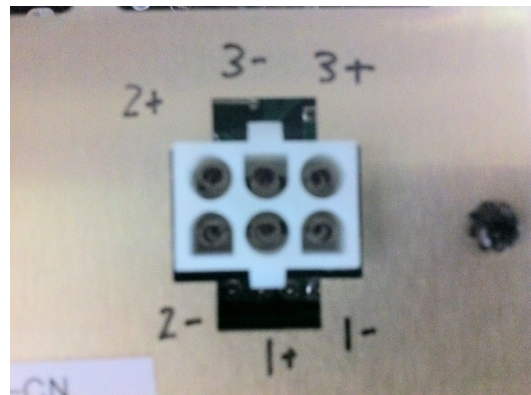
Figure 27: Amplifier Output (Legacy)

With the amplifier on and no signal applied or drivers connected, measure the DC Voltage from each amplifier output pin to the gold colored chassis. If the DC voltages differ from chart below, amplifier is faulty and must be replaced.

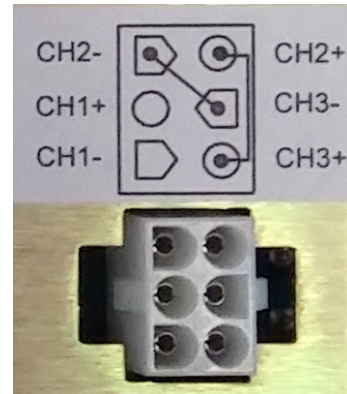
Figure 29: Amplifier Output

With the amplifier on and no signal applied or drivers connected, measure the DC Voltage from each amplifier output pin to the gold colored chassis. If the DC voltages differ from chart below by +/-2V, amplifier is faulty and must be replaced.

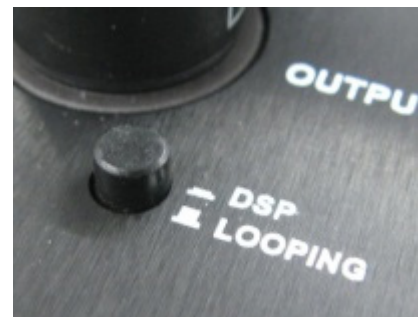
Figure 31: DSP/LOOPING (Legacy)

- Refer to control equipment manuals for proper order of power on/off procedure and see if problem is eliminated.
- If proper procedure is followed, one of the amplifier **DSP/LOOPING** buttons (**Figure 31**) may be stuck between fully out/fully in position. Access to cabinet is required to troubleshoot further. Refer to system riser drawings to understand which amplifiers should be in **LOOPING** and which ones should be in **DSP**.

- **LOOPING** mode: If the button is not depressed (OUT), the male XLR connector is electrically coupled to the input.
- **DSP** mode: If the button is depressed (IN), the male XLR connector will output a filtered signal from the DSP chip. For example, use in the event you want to reroute a channel's pre-amplified signal to the male XLR connector.

Note: Systems built after January 2014 no longer have the **DSP/LOOPING** button.

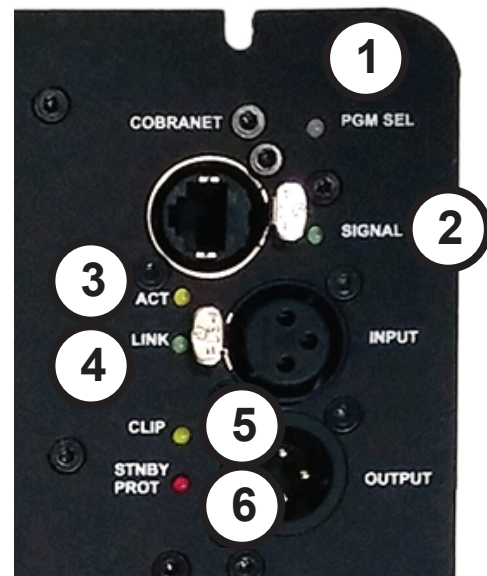
Figure 32: Amplifier Indicator Lights

This section describes the indicator lights on the front panel of Speaker Power's CobraMote model amplifiers. There are (6) LEDs on the front panel, as shown in **Figure 32** and described below:

4. **LINK:** The LINK light will blink with the ACT light when an Ethernet connection is made. It will remain off if there is no connection.
5. **CLIP:** The CLIP light is driven by the primary internal amplifier module and indicates the input level is too high and the amplifier is clipping.

6. **STNBY / PROT:** The standby/protect light indicates the amplifier is in protect mode or channel 1 is muted. It will be on if the amplifier has shut itself down because of a fault, if all channels are put into standby via CobraMote software, or if only channel 1 is muted via software. It will remain off during normal operation or when all channels are muted simultaneously via CobraMote software.
